## Green-tree Reservoir Management Changes – Malmaison Wildlife Management Area

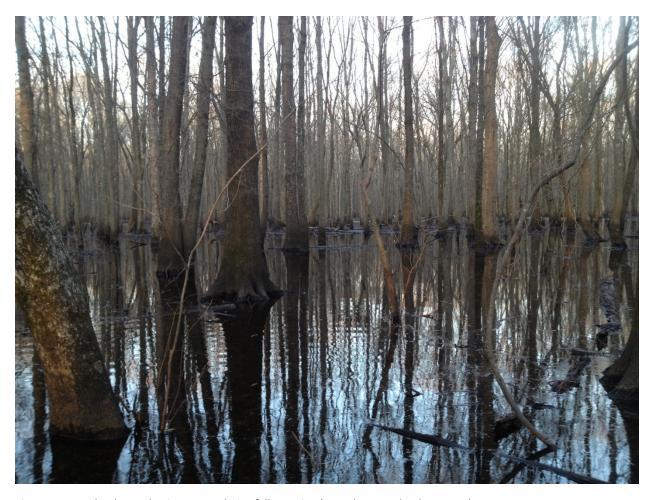
Figure 1: Water level at Malmaison WMA during full capacity. (Note the water levels on trees)

Historically, GTRs across the southeast have been managed similarly. GTR forests were flooded annually, beginning in early-mid fall, and de-watering began late winter. The MAWMA GTR was no different. Prior to 2014, the MAWMA GTR was extensively and deeply flooded annually. Each October, all boards were installed in GTR water-control structures and flooding occurred using groundwater pumps and rain-runoff to achieve full capacity prior to the opening day of the November waterfowl season. Trees were flooded prior to complete winter dormancy and often remained flooded through late February after hardwoods begin emerging from dormancy. De-watering within the MAMWA GTR is often delayed by rises in the adjacent Yalobusha River in late winter through early spring. Frequent, extensive, and deep flooding within the MAWMA GTR benefitted boating access for waterfowl hunting but stressed trees and deteriorated forest habitat for wintering waterfowl.

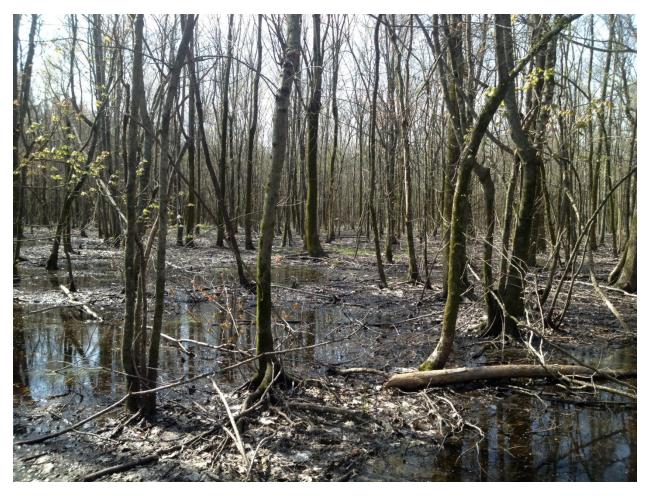
Figure 2: Previous GTR water management has resulted in a shift towards more water tolerant species such as swamp maple.

Due to size and energy content, cherry-bark, nuttall, water, and willow oak acorns are an important food for waterfowl and numerous other species of wildlife. These and other less water-tolerant bottomland hardwood tree species within the MAWMA GTR currently exhibit signs of stress from years of prolonged, deep flooding before full tree dormancy in early winter and continuing after trees began to emerge from dormancy in late February. Prolonged flood stress is evident by thin and dying tree crowns, dead trees, numerous dead limbs on forest floor, decay along tree trunks, and epicormic branching along tree trunks. A shift in tree species composition is occurring within the MAWMA GTR, from desirable food-producing but less water-tolerant oak species previously mentioned to more water-tolerant tree species such as overcup oak, maple, willow, and bitter pecan which produce less waterfowl food. GTR flooding practices prior to 2014 may have decreased acorn production in desirable oak species due to loss of desirable oaks and interruption of carbohydrate and nitrogen uptake important for acorn production. Little to no regeneration of desirable oak species is occurring throughout the GTR due to lack of forest thinnings and poor tree seedling survival from frequent and prolonged flooding.

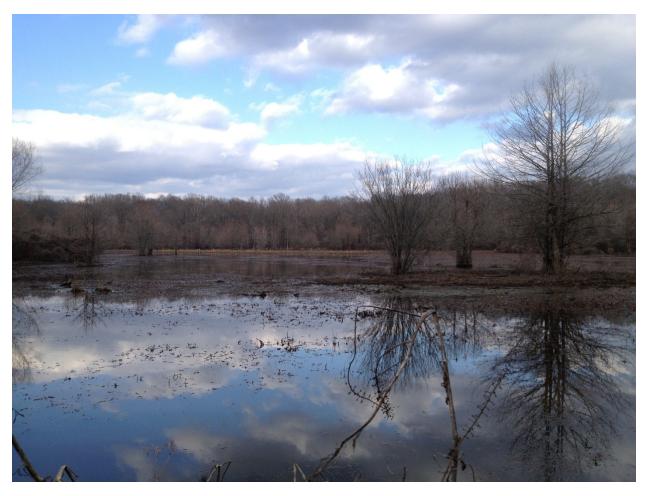
Figure 3. Moist-soil area within the Malmaison WMA GTR during spring drawdown. Previous water depths were generally 1 to 2 feet higher for boating access during most of the waterfowl hunting season. Conditions pictured here are ideal for waterfowl foraging.

Ideal foraging depth for dabbling ducks ranges from 4 to 18 inches. MAWMA flooding practices prior to 2014 significantly decreased waterfowl foraging habitat. By the time regional duck abundances peaked each winter, water depths across much of the MAWMA GTR were too deep for dabbling ducks to reach submerged foods resting on the forest floor such as acorns, insects, and grass seeds.
